Assessment of current and projected stormwater runoff dynamics before major land use changes at SUNY Purchase College

Submitted to the Board of Environmental Studies

May 2021

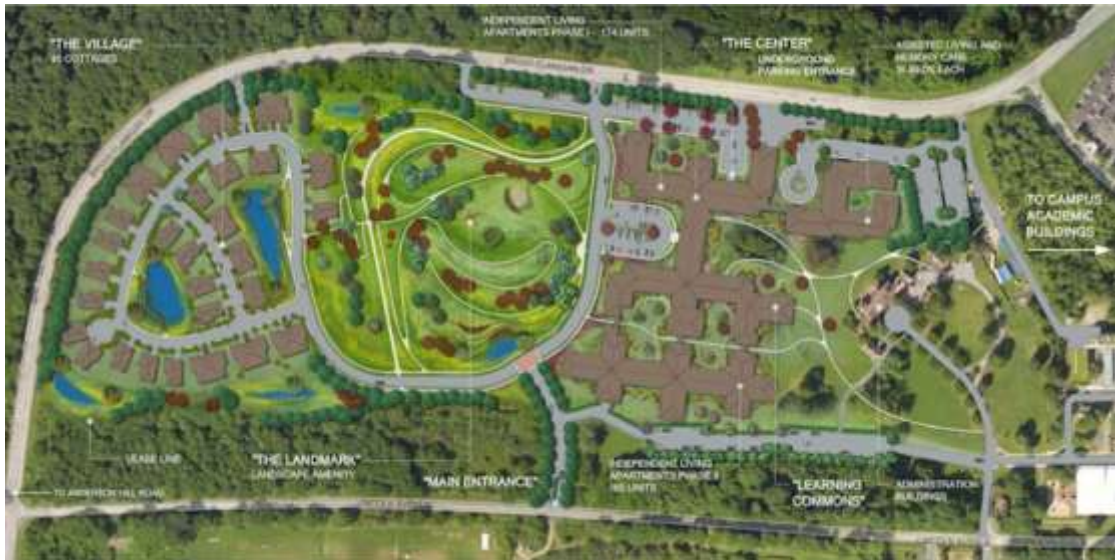
Figure 4 An artist's rendering of the future Broadview facility layout (Divney Tung Schwalbe, 2017).

disturbances. The facility will have 385 residential units in total. 339 of those units will be in a four-story apartment building behind the admissions building. The remaining 46 units will be arranged in 29 single-story cottage-style buildings separated by a vegetated walking area (figure 4).

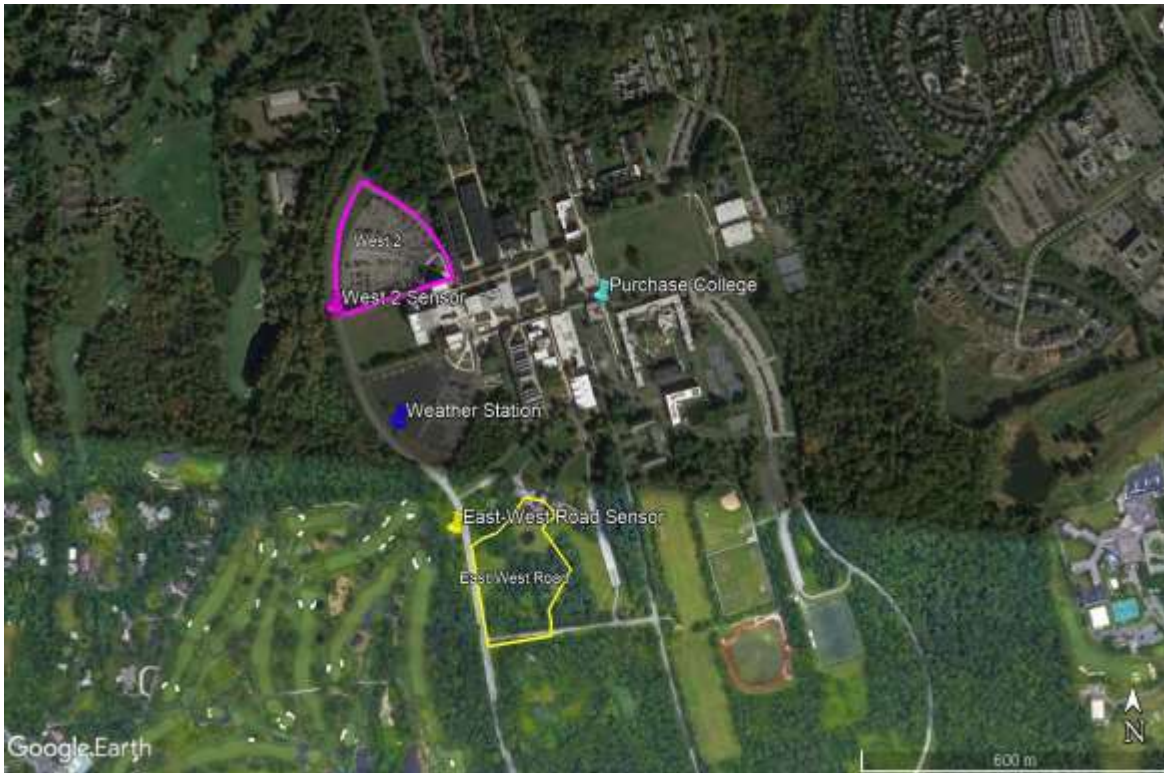
Figure 5 Site and sensor locations on the Purchase campus.

Stormwater runoff quantity measurements were taken from the West 2 drainage pipe and the East-West Road drainage pipe (figure 5). Rain data was taken from the Weather Station located in the bioswale at the bottom of the West 1 parking lot in between East-West Road and West 2 (figure 5). The HOBO RX3000 sensors and weather stations were purchased through a grant given to the college by the Regional Economic Development Council and installed by Paola Valencia (ENV '20) for her senior project (Tallaferro, 2015). Data was collected and stored remotely via the cloud and accessed on the HOBOLink website. This study took place over six months, from

This study consists of two sample sites in the western half of the SUNY Purchase College campus (figure 5). The West 2 site consists primarily of asphalt parking lot in poor condition as well as a small section of vegetated area. The site is 8.85 acres in total. There are 7.73 acres (87.4%) of impervious asphalt and 1.11 acres (12.6%) of vegetated area covered in grass (figure 6).

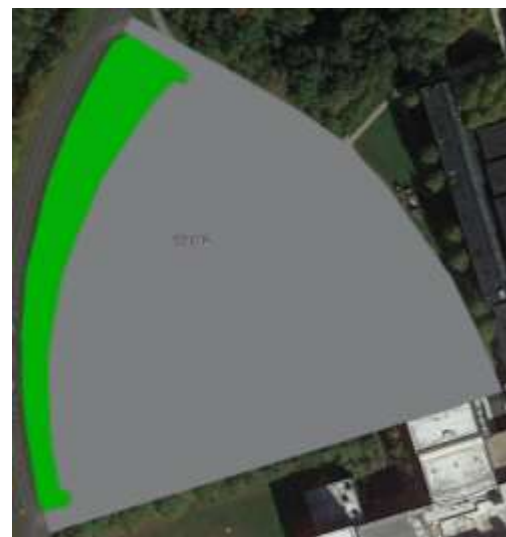
Figure 6 West 2 land cover types (green=vegetation, gray=asphalt).

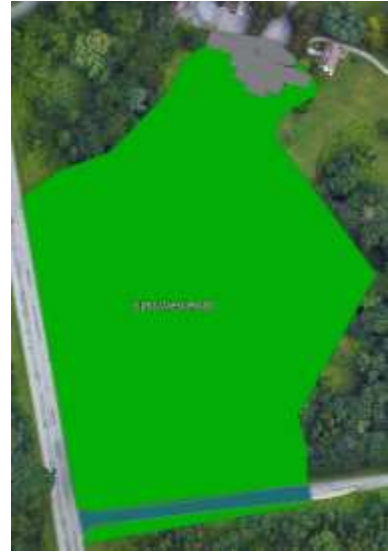
Figure 7 East-West Road land cover types (green=vegetated area, gray/blue=impervious surface).

The East-West Road site consists primarily of vegetated woodlot but also includes part of the road and the runoff from the admissions building for the college. Impervious surface makes up 0.59 acre (6.9%) of the 8.62 acre site, while the other 8.03 acres (93.1%) consist of woodlot and grass patches (figure 7).

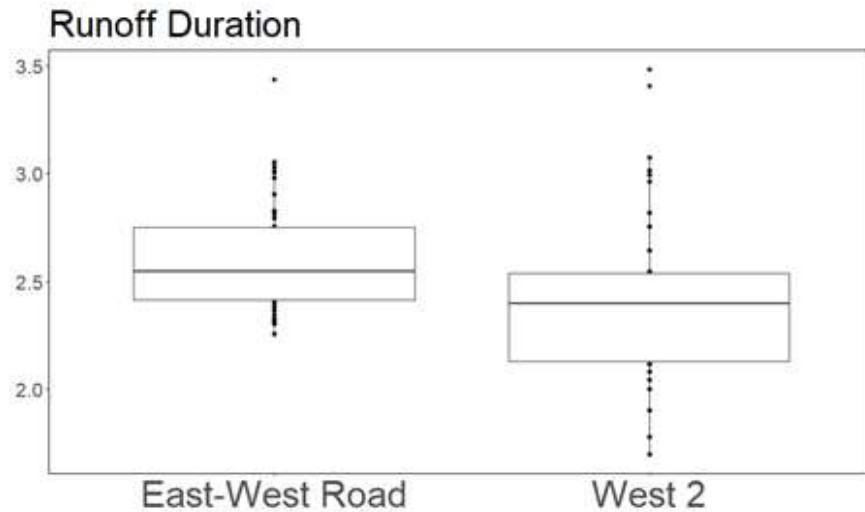
Figure 10 The boxplot for R_D for all storms.

For all 43 rain events R_D showed a significant statistical difference between East-West Road and West 2 (unpaired t-test, $t=2.52$, $P=0.014$) (figure 10). The mean R_D was larger for East-West Road (mean=2.6 + 0.07 CI, $N=43$) than it was for West 2 (mean=2.42 + 0.1 CI, $N=43$).

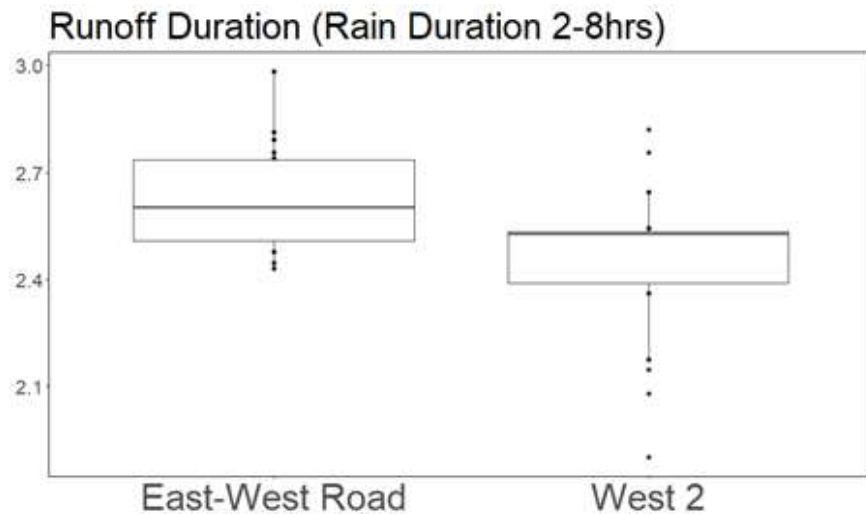
Figure 13 The boxplot for R_D where rain duration was between two and eight hours (120-480min).

For rain events that lasted between two and eight hours (120-480 minutes) significant statistical difference was found between the two sites (unpaired t-test, $t=2.72$, $p=0.01$) (figure 13). The mean R_D for East-West Road (mean=2.62 + 0.06 CI, N=20) was larger than mean R_D for West 2 (mean=2.46 + 0.09 CI, N=20).

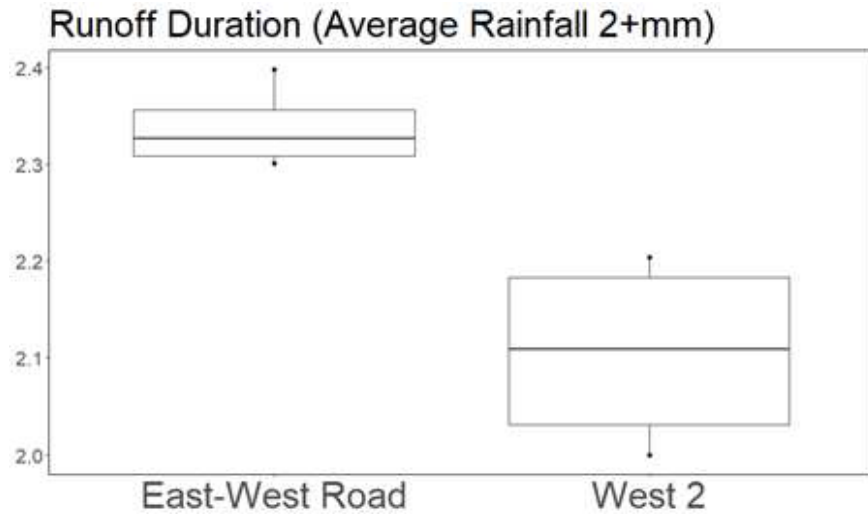
Figure 14 The boxplot for R_D when average rainfall is greater than 2mm.

For rain events that had a rainfall average greater than two millimeters, significant statistical difference was found (unpaired t-test, $t=4.27$, $P=0.01$) (figure 14). The R_D mean for East-West Road (mean=2.34 + 0.05 CI, N=4) was larger than for West 2 (mean=2.1 + .012 CI, N=4).

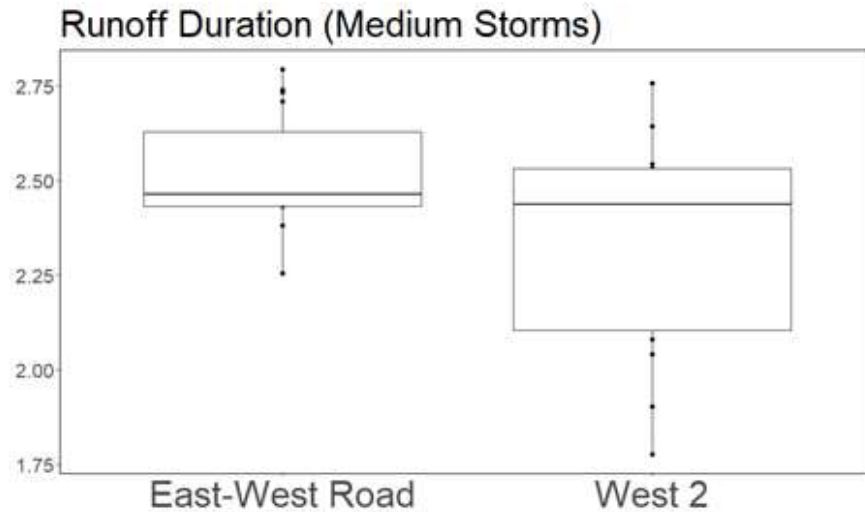
Figure 16 The boxplot for R_D for medium sized storms.

For medium-sized storms, there was a significant statistical difference between East-West Road and West 2 (unpaired t-test, $t=2.51$, $P=0.02$) (figure 16). The R_D mean for East-West Road (mean=2.53 + 0.07 CI, N=16) was larger than for West 2 (mean=2.32 + 0.13 CI, N=16).

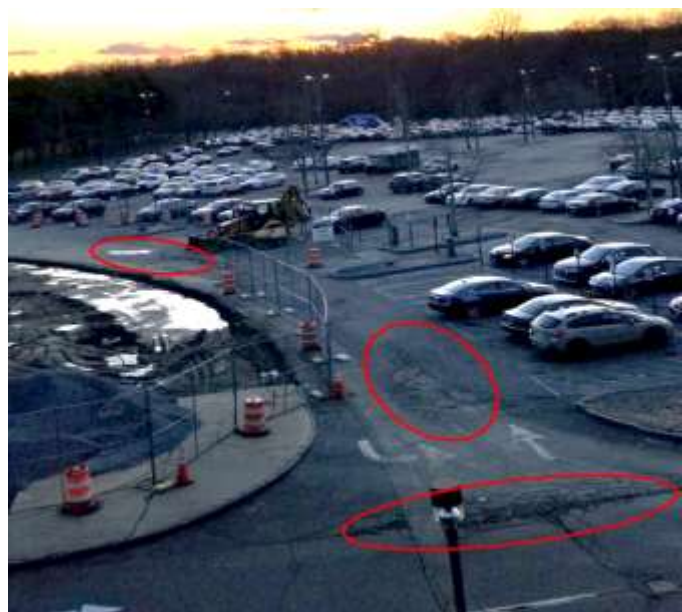
Figure 17 A view of West 2 from the music building with red circles around examples of damage (February 2020).

The condition of West 2 (figure 17) may also have affected runoff times at that site. The runoff rates of impervious surfaces like asphalt have been shown to be 70 to 100% of water when the surface is pristine (Salt and Kjeldsen, 2018). West 2 is not a pristine surface. It has a reputation among students and staff to be full of

potholes that have only worsened every year through freeze-thawing in the colder months. The presence of cracks and other deformities in pavement has been shown to allow infiltration into the ground below (Salt and Kjeldsen, 2018; Redfern, 2016). This means that the infiltration rate of impervious areas increases as there are more cracks and other deformities. Water ponding in potholes and infiltrating through large cracks would have slowed D_p and R_D at West 2, making it more similar to East-West Road.

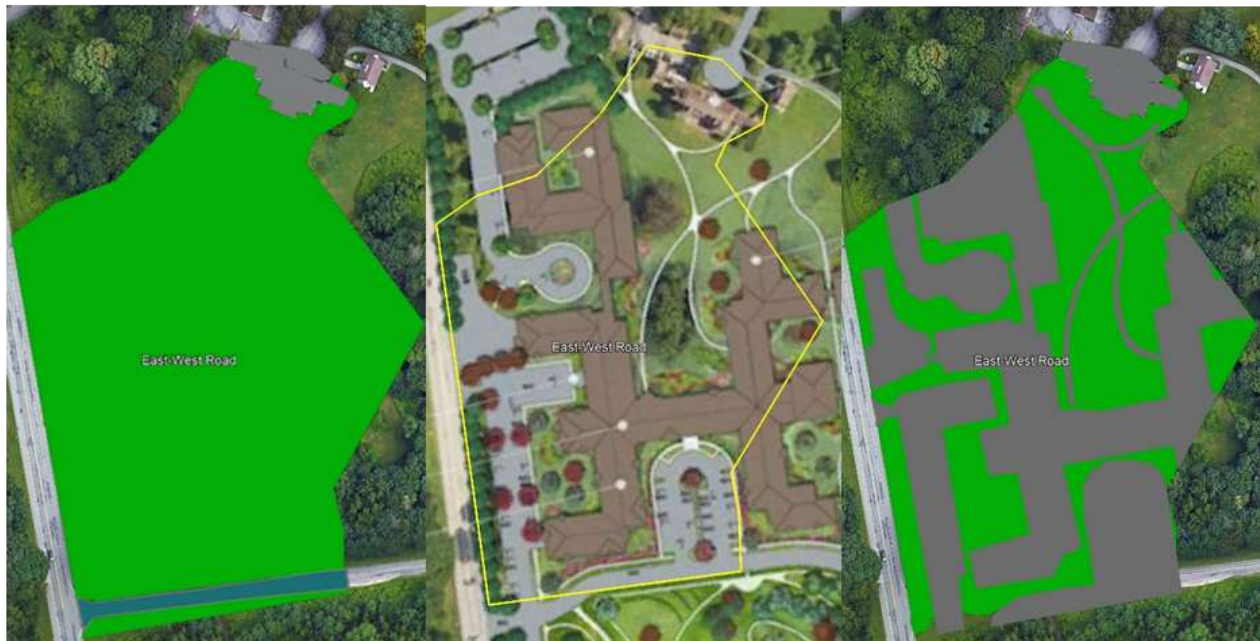
Figure 18 Current East-West Road conditions vs. future changes in land use and impervious surface. Green= vegetated areas, gray/blue= impervious surface

When Broadview is completed, there will be large changes to the whole East-West Road site (figure 18). For the whole area there will be an increase in impervious surface from 0.59 acres in total to 4.77 acres total. This is a 709% impervious surface increase in just the East-West Road site. The whole facility will be much larger (refer to Figure 3) and will have major implications for runoff in other areas of campus as well.

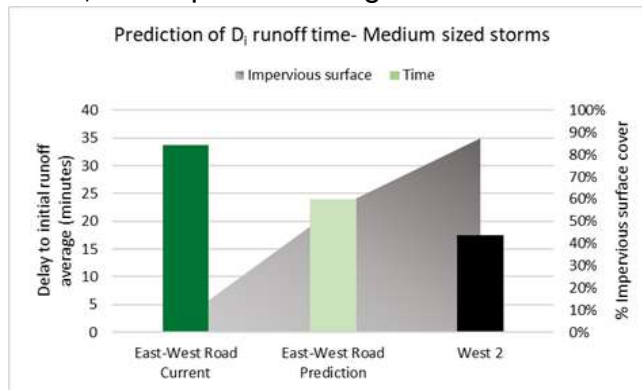
Figure 19 Future prediction of D_i for medium storms, a 28.97% decrease in runoff time.

Since the approximate change in impervious surface is known, the new amount of impervious surface can be used to calculate future runoff conditions. Calculations were done by taking the current time difference and dividing it by the difference in impervious area between the two sites. That number was then multiplied by the difference in future and current impervious area at the East-West Road site. The result of that calculation was subtracted from the current East-West Road time average and that result was the prediction of future runoff time. In all cases where there was a significant result, these future calculations were done. Every instance shows a result where D_i , D_p , and R_D would be faster than what they are now (figure 19, figure 20, figure 21). Average runoff time was reduced by 25% overall, but ranged from 7.79% for R_D for all storms and 39.1% for D_p when peak rain is greater than 5mm.
